# **INDOOR AIR QUALITY ASSESSMENT**

**Department of Industrial Accidents  
1 Father DeValles Boulevard  
Fall River, Massachusetts**

Prepared by:  
Massachusetts Department of Public Health  
Bureau of Environmental Health  
Indoor Air Quality Program  
August 2016

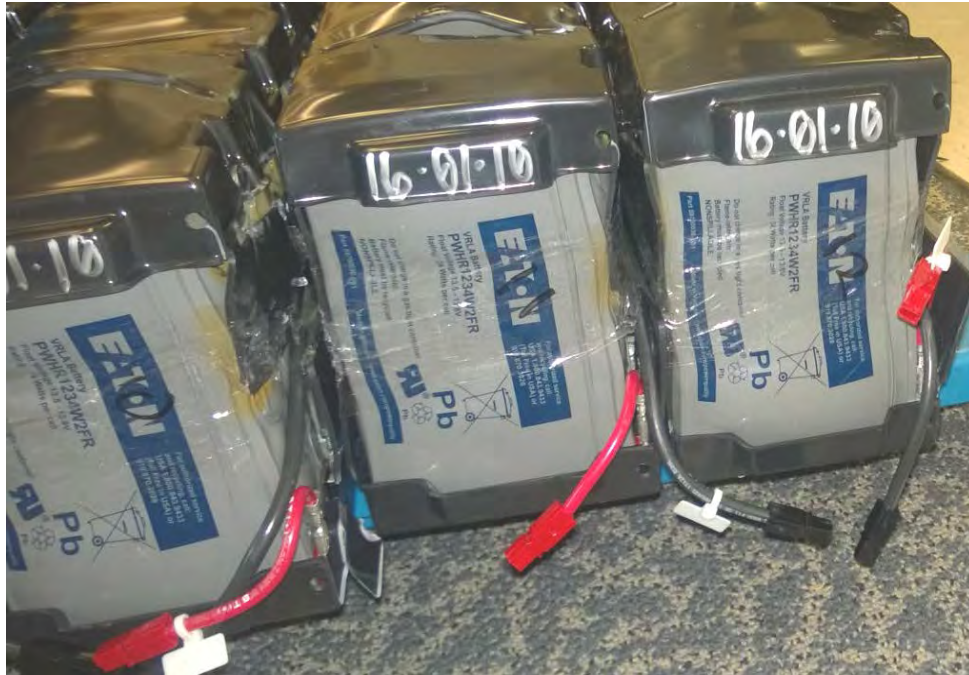
**Picture 1**

It was reported by DIA staff that due to a malfunction of the air conditioning (AC) system, elevated temperatures were experienced in the IT/computer equipment room that reportedly caused lead acid batteries to expand, releasing gas/odors into the air (likely including sulfuric acid) (Picture 1). In the days following, DIA staff reportedly experienced symptoms including metallic taste in mouth and allergenic and respiratory irritation. As a result, a professional remediation company, Service Master, was contacted to conduct clean-up of the space. Service Master cleaned the flat surfaces in the office and used air scrubbers to remove contaminants from the air.

It is possible that these symptoms resulted from the presence of plastic residue that melted and became aerosolized during this incident. Burnt plastic odor can be irritating to the eyes, nose and respiratory system. Of note was a clear plastic tape that was wrapped around the batteries (Picture 1). It is possible the heat and/or sulfuric acid caused the clear plastic to degrade and release plastic residue into the air. In addition, insulation on piping within the air-conditioning (AC Unit) installed in the IT Room appears to have melted (Picture 4).

**Computer room battery, note distended shape and clear plastic wrap/tape  
(Photo provided by Paul A. Przysztarz, Regional Manager, Department of Industrial Accidents)**

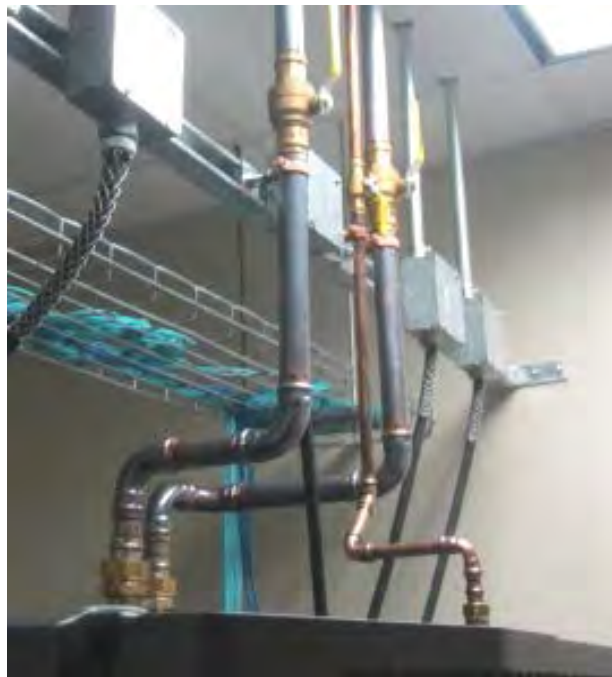
**Picture 2**

At the time of the MDPH/BEH assessment, no sulfur-related odors were detected; however a few DIA staff members were reporting on-going symptoms of irritation. Sulfuric acid vapor will interact with copper to cause it to have a darkened stain (Picture 2). No darkened copper piping was noted in the ceiling plenum *above* the IT room (Picture 3). This finding indicates that sulfuric acid vapor was confined mostly to the IT room interior. As reported by Mr. Hamilton, surface pH samples of areas in the IT room were neutral, indicating that no acid residue was detected on sampled surfaces.

**Darkened copper pipe in IT room**

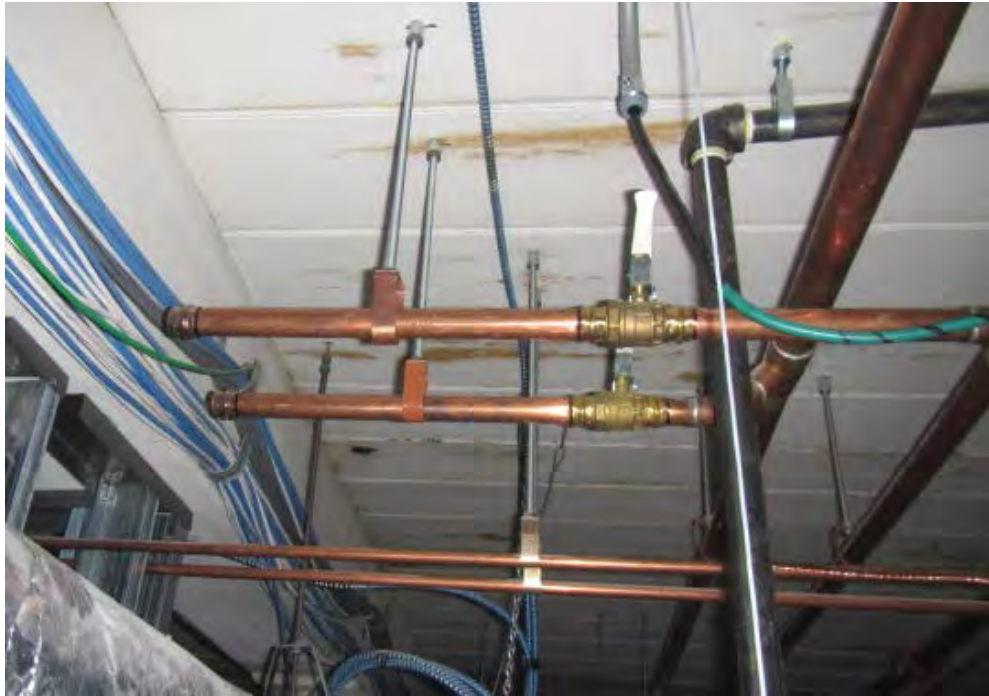
**Picture 3**

**Non-discolored pipe in ceiling plenum above IT room**

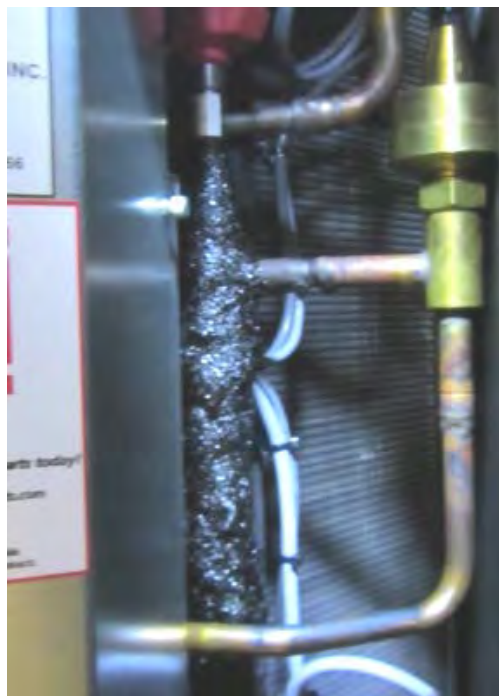
**Picture 4**

**Possibly melted insulation, note copper pipe discoloration adjacent to insulation**

2. Examine whether the insulation in Picture 4 has melted and replace if needed.
3. Consider relocating unused return duct found in the ceiling plenum above IT Equipment room to adjacent courtroom.

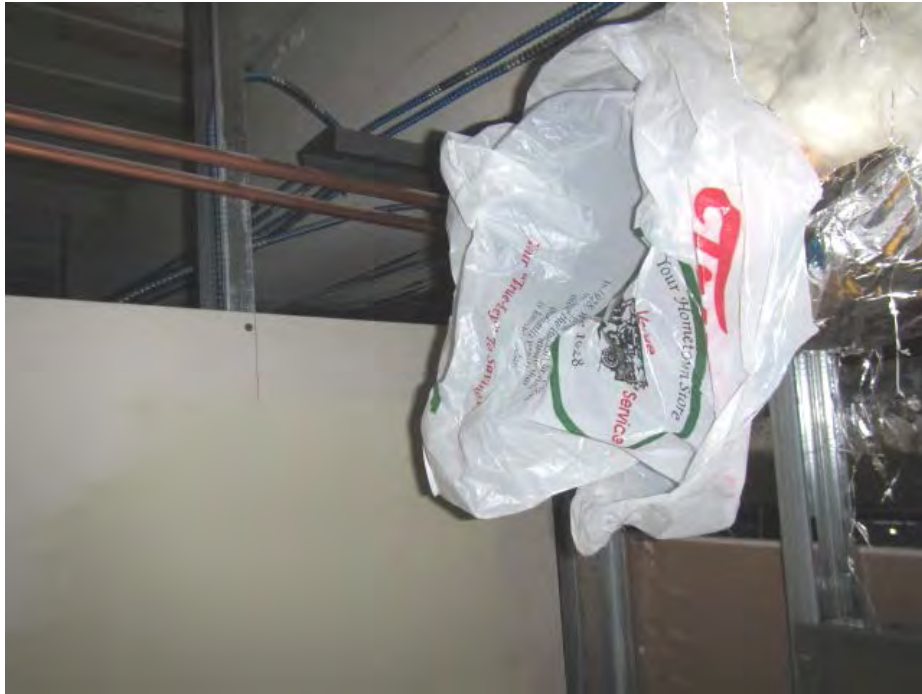
**Picture 5**

If melted plastic becomes airborne, any device that either directs air by convection (e.g., electrical panels) or by powered fans (e.g., computer equipment, return air ducts) can draw these materials in the air, which would readily coat surfaces within the air stream. Such equipment could serve as a reservoir for continuous odors. Of note was the existence of an open and operating return duct *above* the IT room in the ceiling plenum (Picture 5), which appeared to

have been previously used for airflow. This duct appears to be connected to the general HVAC system, which can draw odors/particulates and distribute them to other areas of the floor.

**Open return vent above IT room (sealed with shopping bag by BEH/IAQ staff)**

- Seal the open duct found above the ceiling in the IT room and have it properly labeled in case of future use.
- Inspect the electrical panel on the wall behind the Eaton battery unit in the IT room.
- Evaluate the heating, ventilating and air-conditioning (HVAC) system for provision of fresh air introduction.
- Clean additional offices serviced by the fan coil unit (FCU) outside Regional Director's office.
- Work with battery manufacturer to determine why meltdown occurred to prevent reoccurrence; and
- Perform a complete fresh air "Flush" of the building if possible, based on the evaluation of the HVAC system (OHI, 2016).

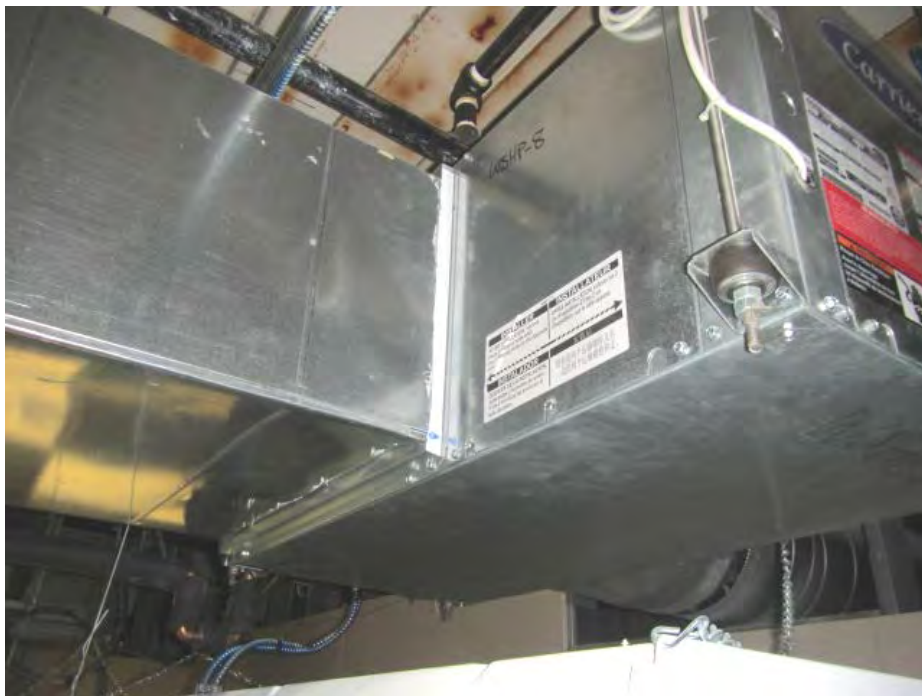
**Picture 6**

The HVAC system consists of a number of fan coil units (FCUs, Picture 6) located above ceiling tiles throughout the floor. It was not clear how or if these units provided fresh outside air to the space. Air is filtered, heated/cooled, and directed to occupied spaces via ducted ceiling vents (Picture 7). Return air is vented through ceiling-mounted vents back to the FCUs (Picture 8). The system is controlled by digital wall thermostats. IAQ staff examined the abandoned return vent (Picture 5) and traced it to a FCU unit in the ceiling of the hallway on the northwest corner of the building. Of note is that this same duct completely traverses the ceiling plenum above the adjacent courtroom ceiling, with no return/intake opening that would draw air from the occupied space.

**FCU in ceiling plenum**

1. Implement the recommendations made by OHI, particularly those in relation to examining the HVAC system for adequate introduction of fresh/outside air.

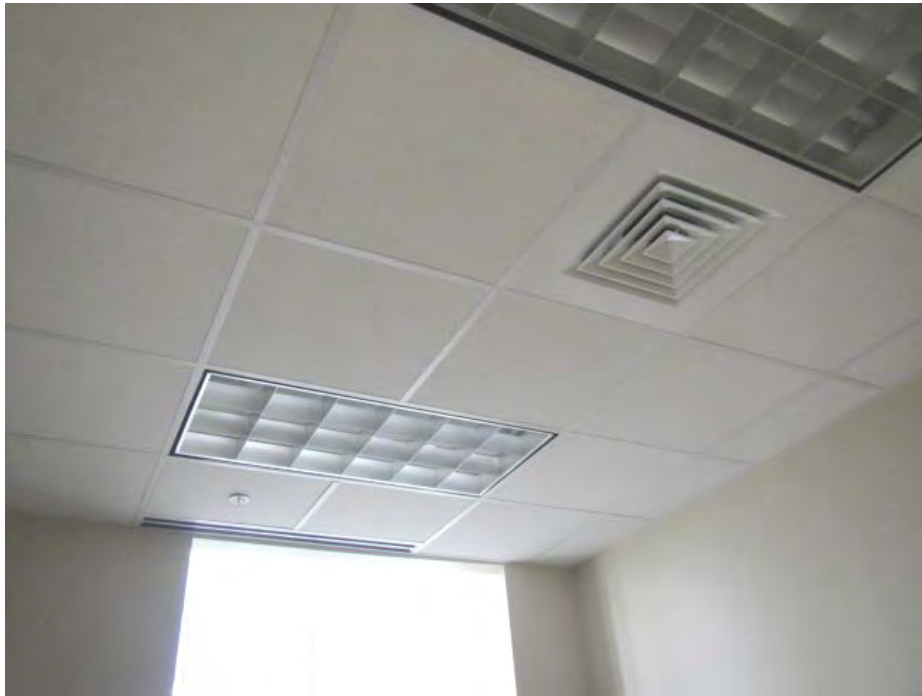
**Picture 7**

**Fresh air supplies**

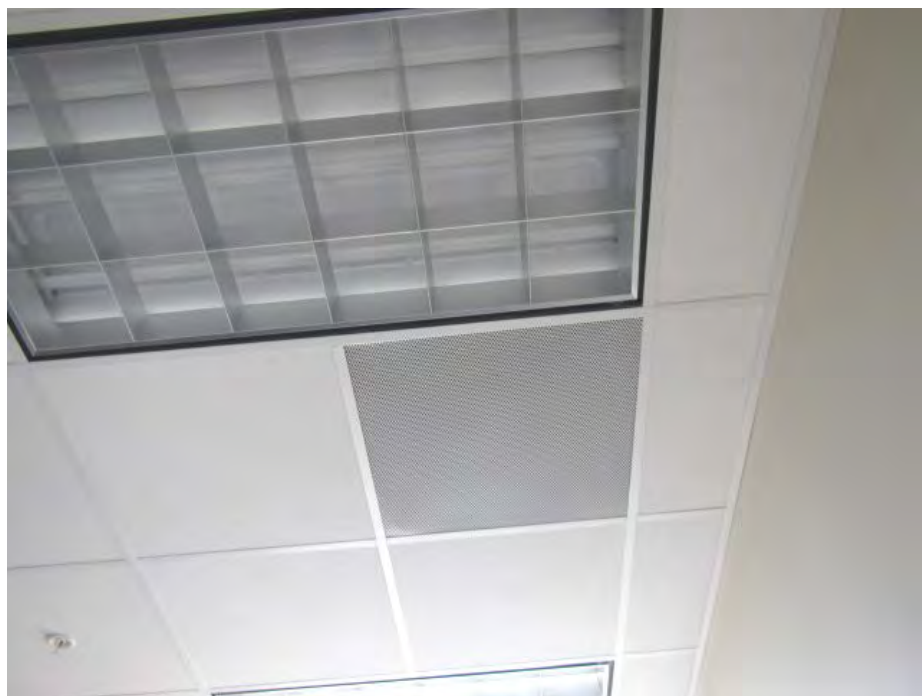
**Picture 8**

**Return vent**
